FAILURE OF TETON DAM

A REPORT OF FINDINGS

by
U.S. DEPARTMENT OF THE INTERIOR
TETON DAM FAILURE REVIEW GROUP
April 1977

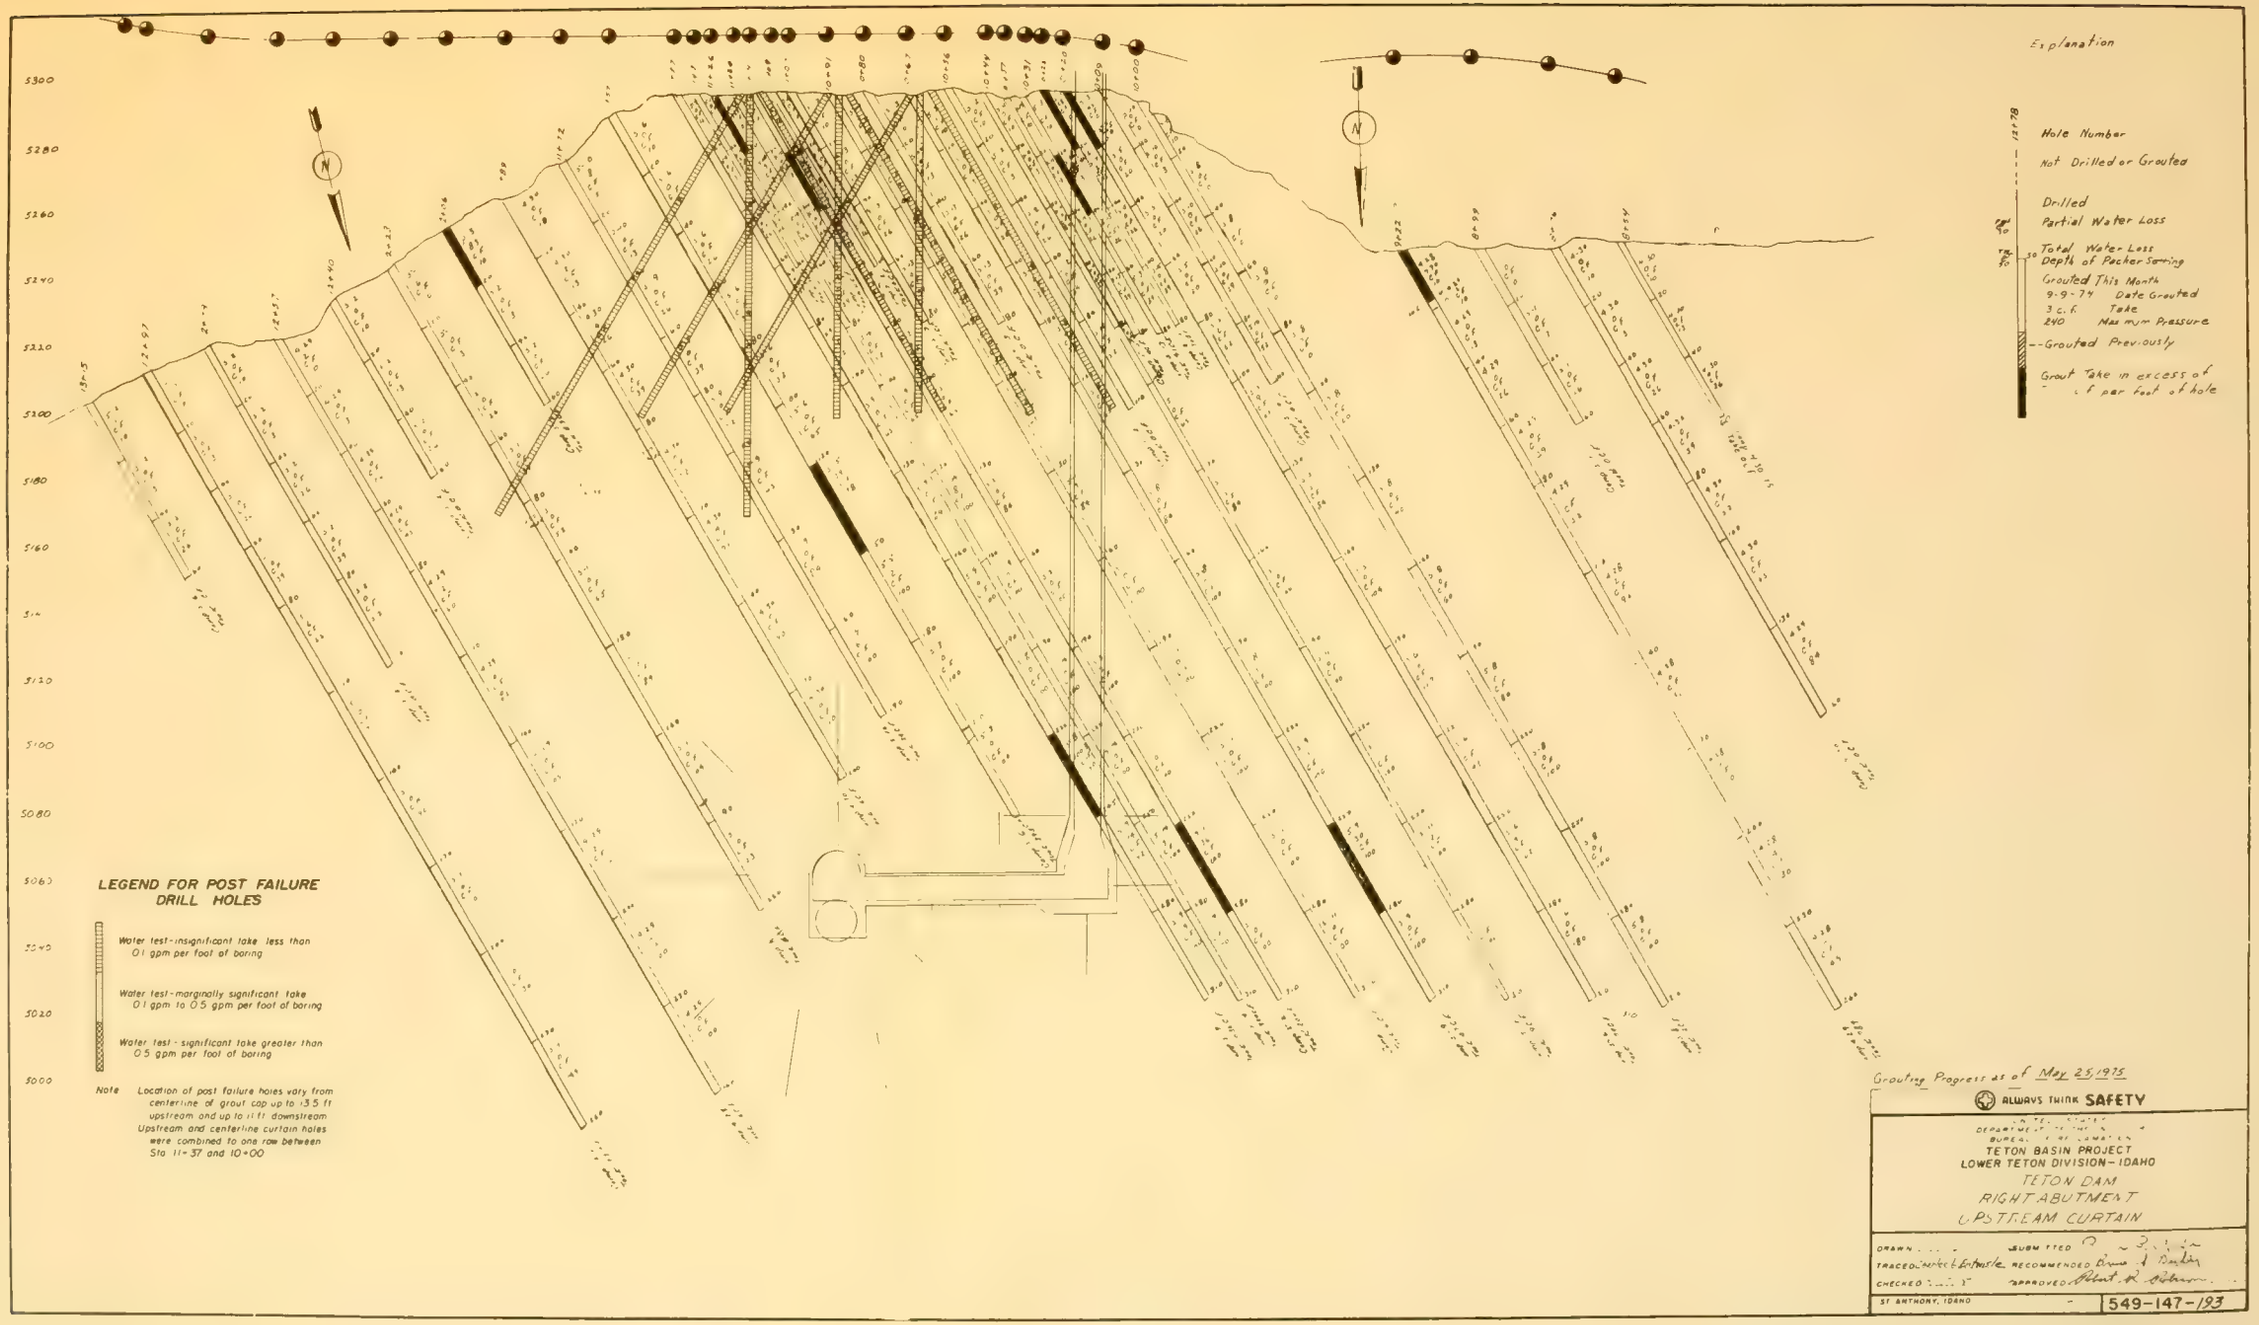
Figure 33.—Details of the right abutment centerline grout curtain including postfailure core borings (sheet 3 of 3).

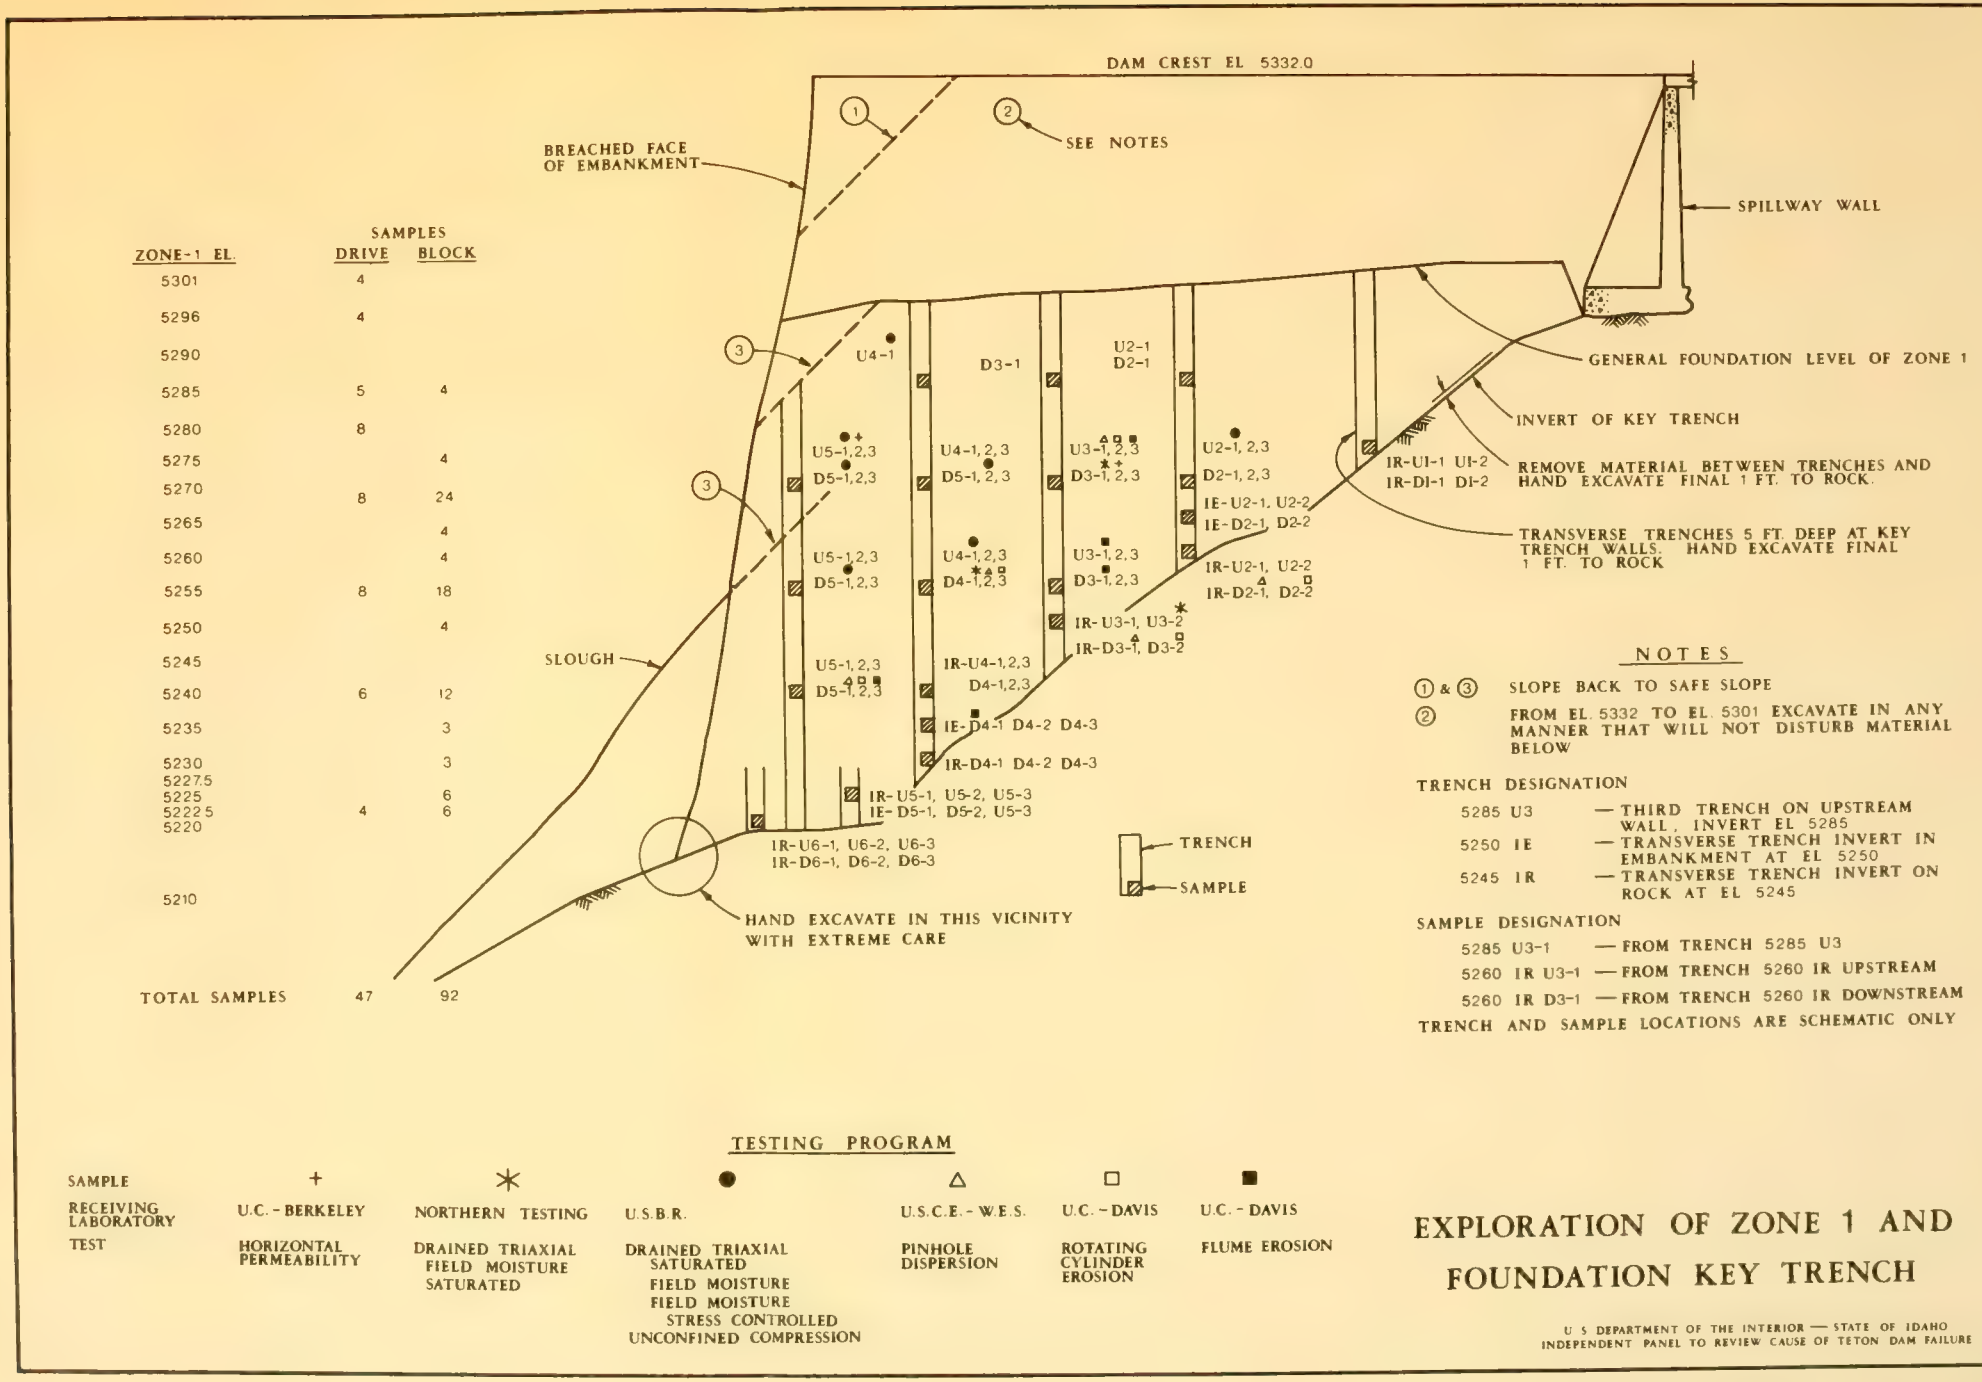
Figure 35.—Exploration of zone 1 and foundation key trench.

Zone 1 compaction at the contact with foundation rock surfaces was generally equivalent to that within the body of the fill. Joints and fractures in the key trench walls were numerous, with openings up to 6 inches wide. There was little evidence of surface grouting in joints exposed in the key trench walls.

The laboratory tests, in addition to providing input parameters for the finite element analysis, confirmed the highly erodible nature of the zone 1 material and its brittle characteristics when compacted dry of optimum moisture content.

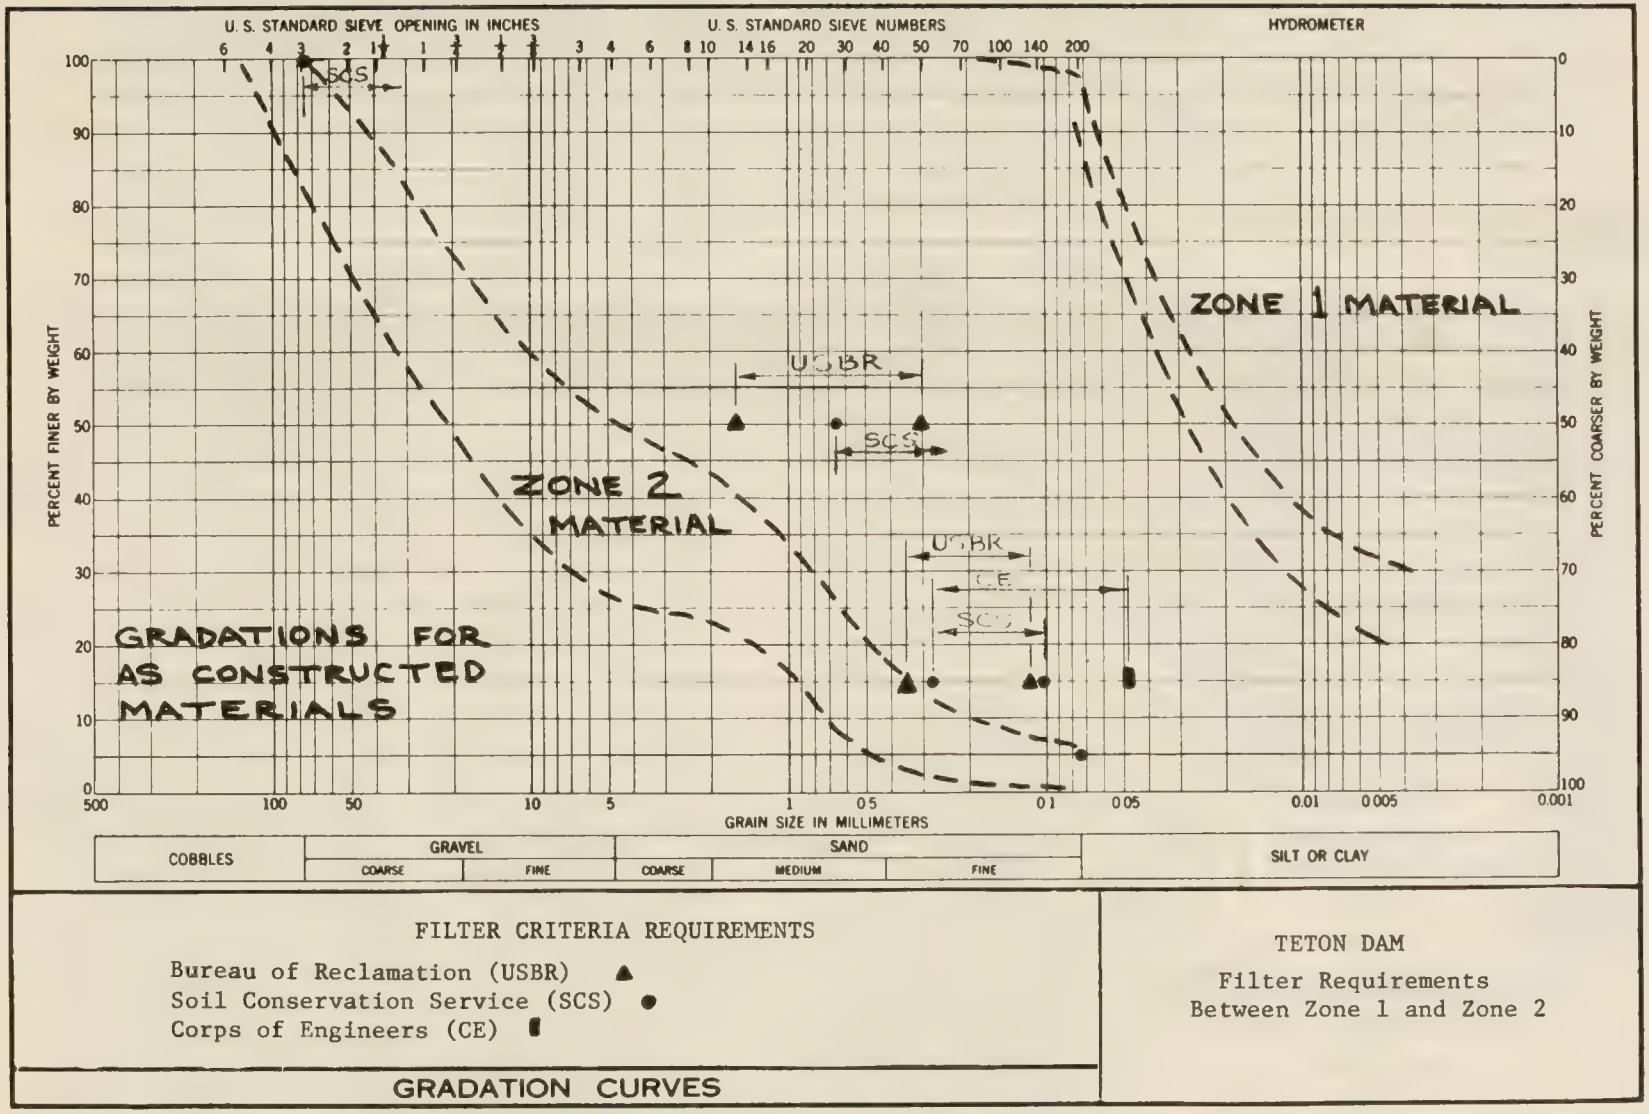
Figure 36.—Filter requirements between zone 1 and zone 2.

Tests performed on zone 2 material after completion of the design are presented on Figures 36 and 37. Figure 36 shows the range of gradation curves for zone 1 material; limits of gradation for zone 2 as required by Corps of Engineers, Soil Conservation Service, and Bureau of Reclamation design standards; and the

range of as-constructed gradation curves for zone 2 material. Figure 37 shows the results of permeability tests on zone 2 material. Permeabilities are grouped into three categories ranging from "practically impervious" to "good drainage."

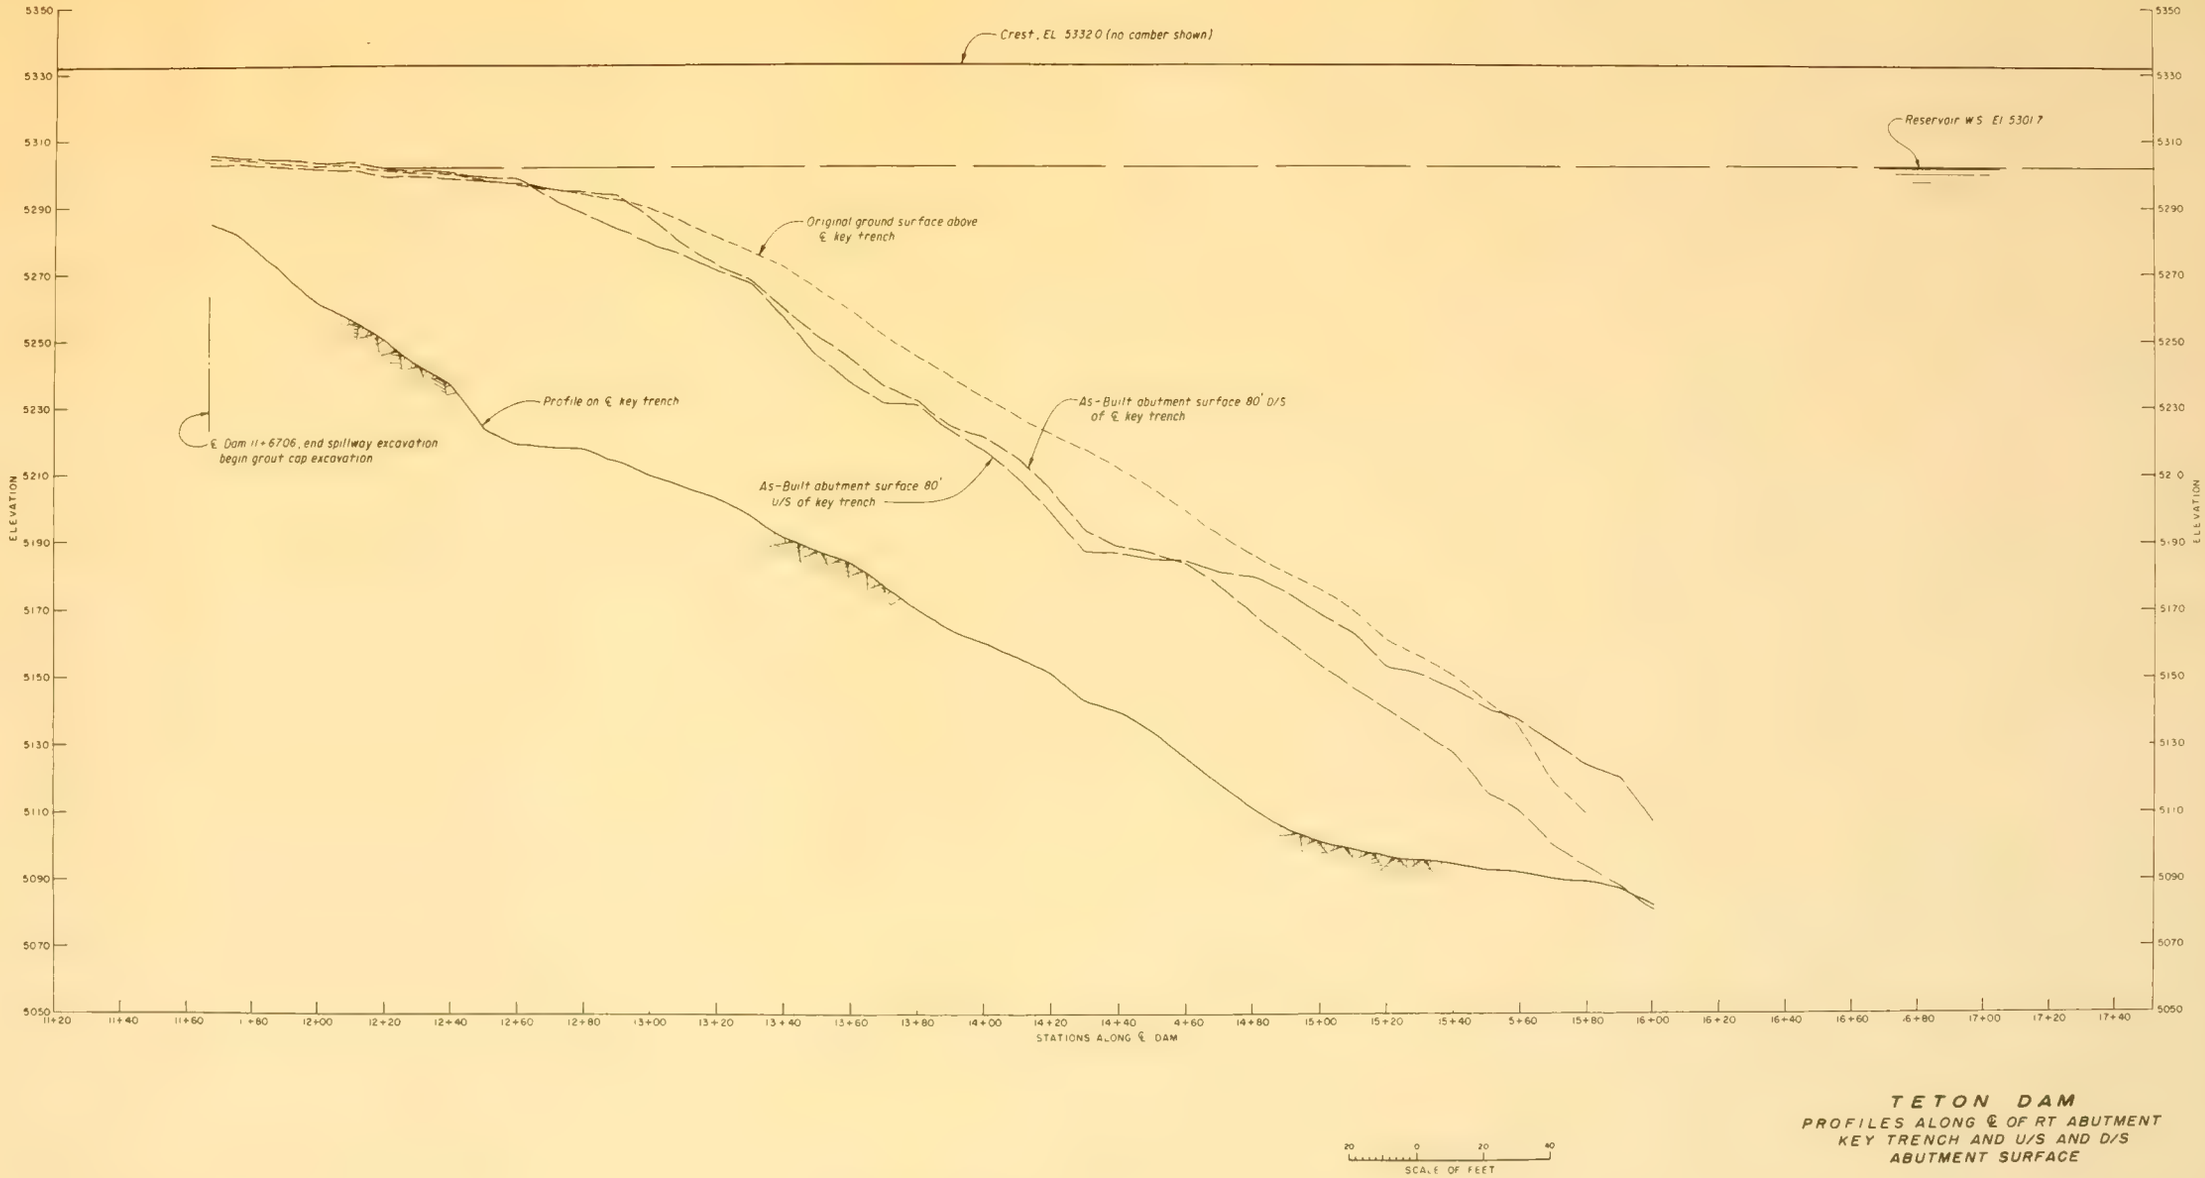
Figure 38.—Profiles along ℄ of Rt. abutment key trench and U/S and D/S abutment surfaces.

Design of Key Trenches.–It was recognized early in the design that the silty core material had a high potential for cracking. It was also recognized that cracking would be aggravated by the geometry of the foundation. The following are direct quotes from design notes by the principal designer:

The design of the key trench came later, during the period for which no design documentation is available. A profile of the right key trench is shown on Figure 38.

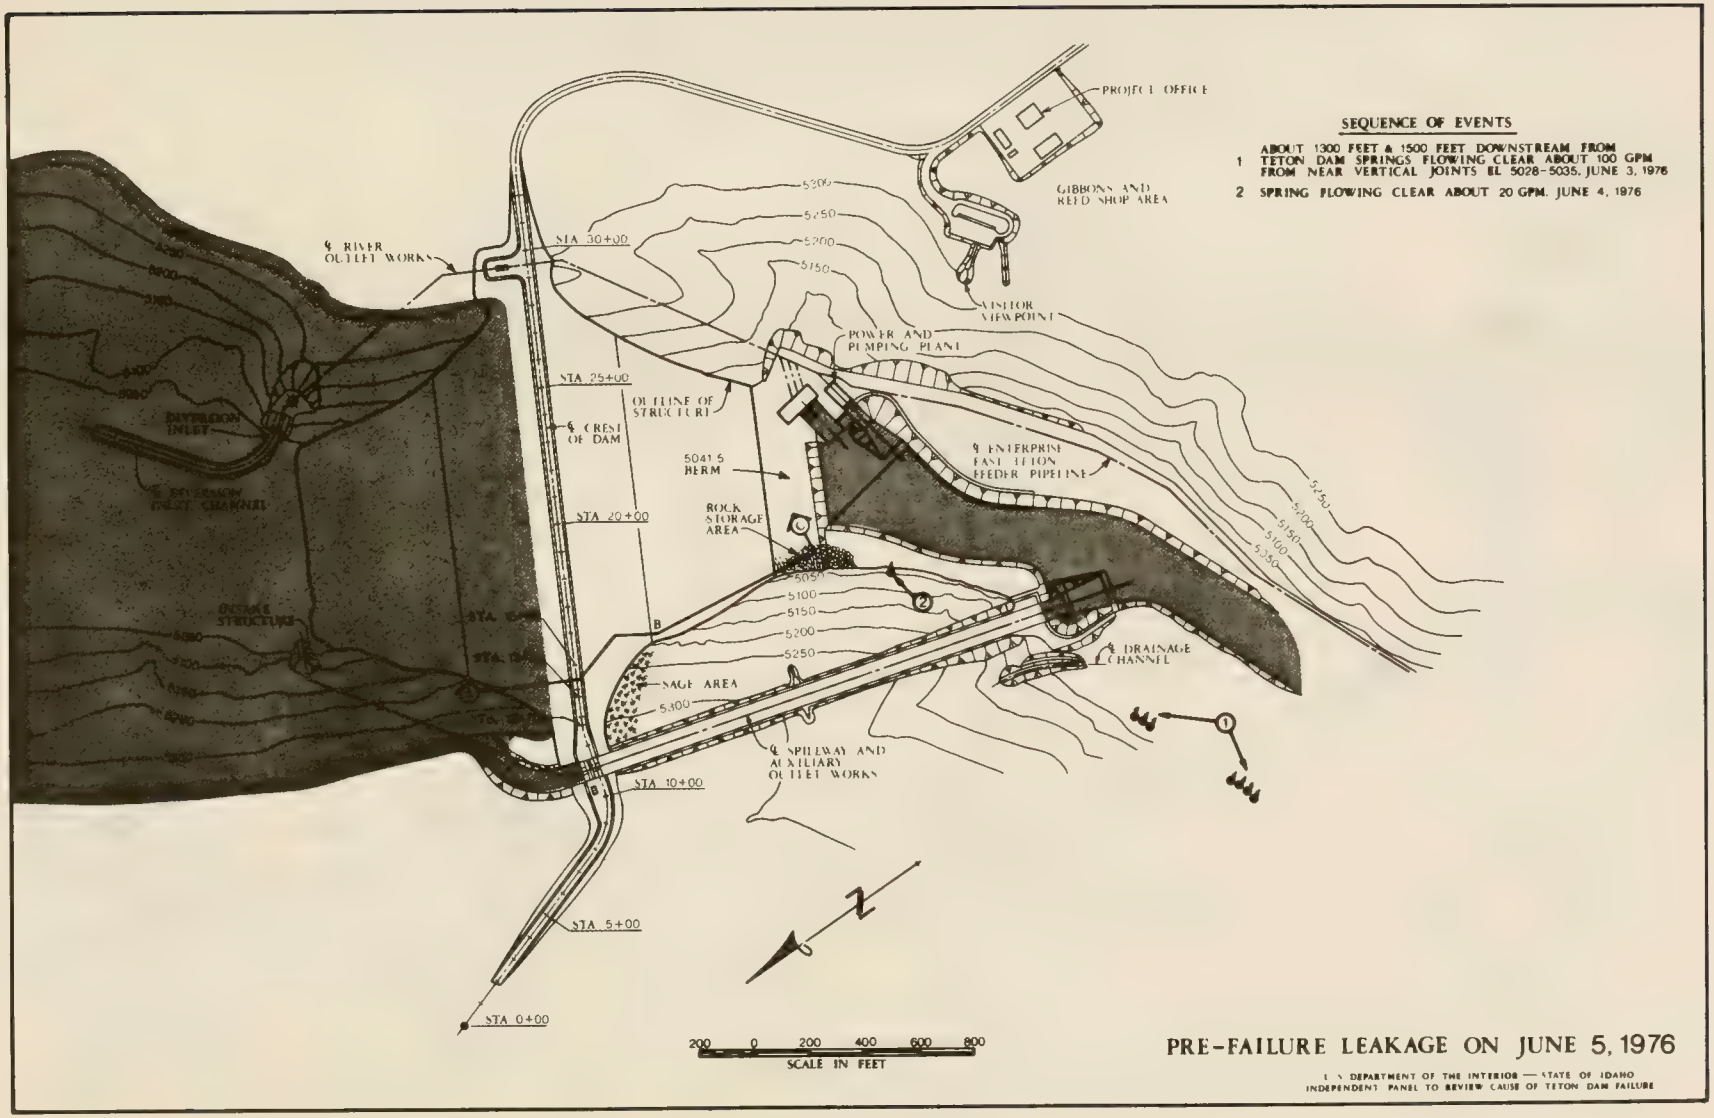
Figure 39.—Pre-failure leakage June 5, 1976.

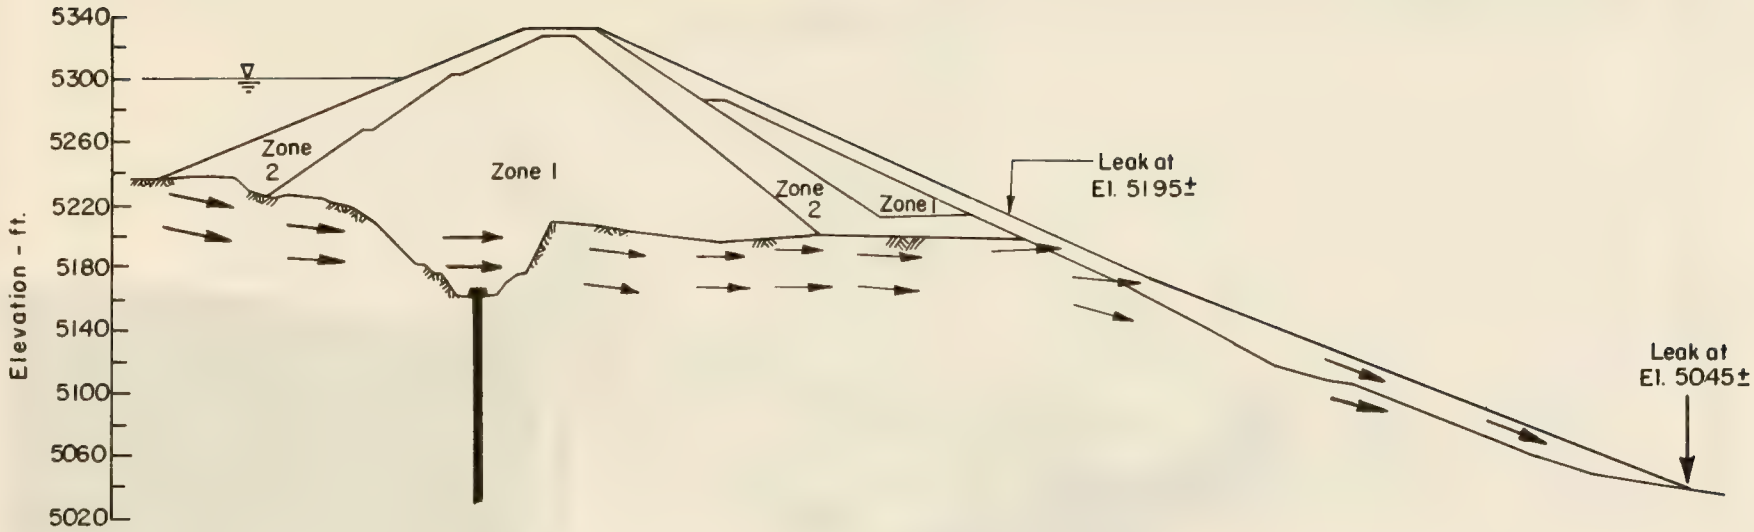
PROBABLE PATH OF WATER IN EARLY STAGES OF LEAKAGE

"Several days before the final failure, leakage through the key trench fed water at a slowly increasing rate into a number of diagonal joint systems; a portion of this flow entered the joints directly, and a portion entered via the overlying highly fractured rhyolite and talus above El. 5200. As the joint systems began to fill with water, aided by water flow around the end of the right abutment key trench fill, quiet discharges of water occurred several days before the actual failure. Some of the discharges emerged along the base of the canyon wall downstream from the dam (see locations 1 and 2 in Fig. 39[1] and some moved as subsurface flows into the contact zone of talus and heavily jointed rock beneath the zone 2 and zone 5 portions of downstream part of the embankment (Fig. 40).

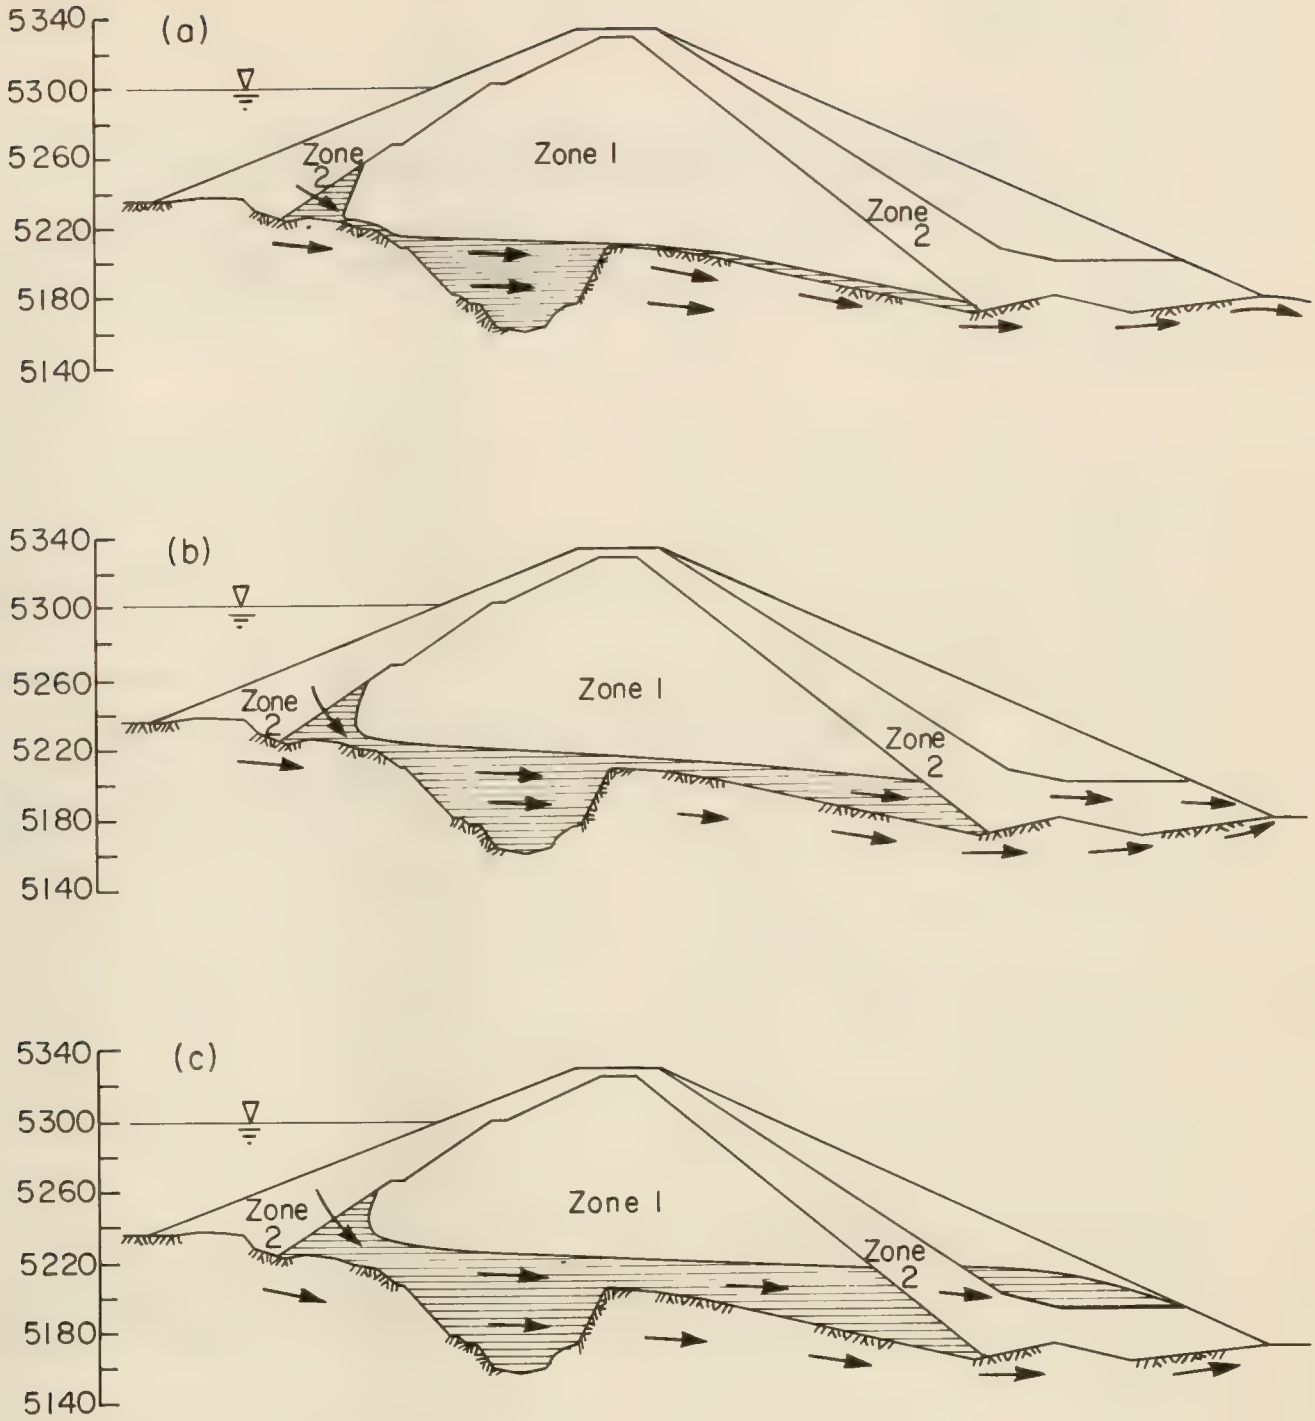
Figure 40.—Probable path of water in early stages of leakage.

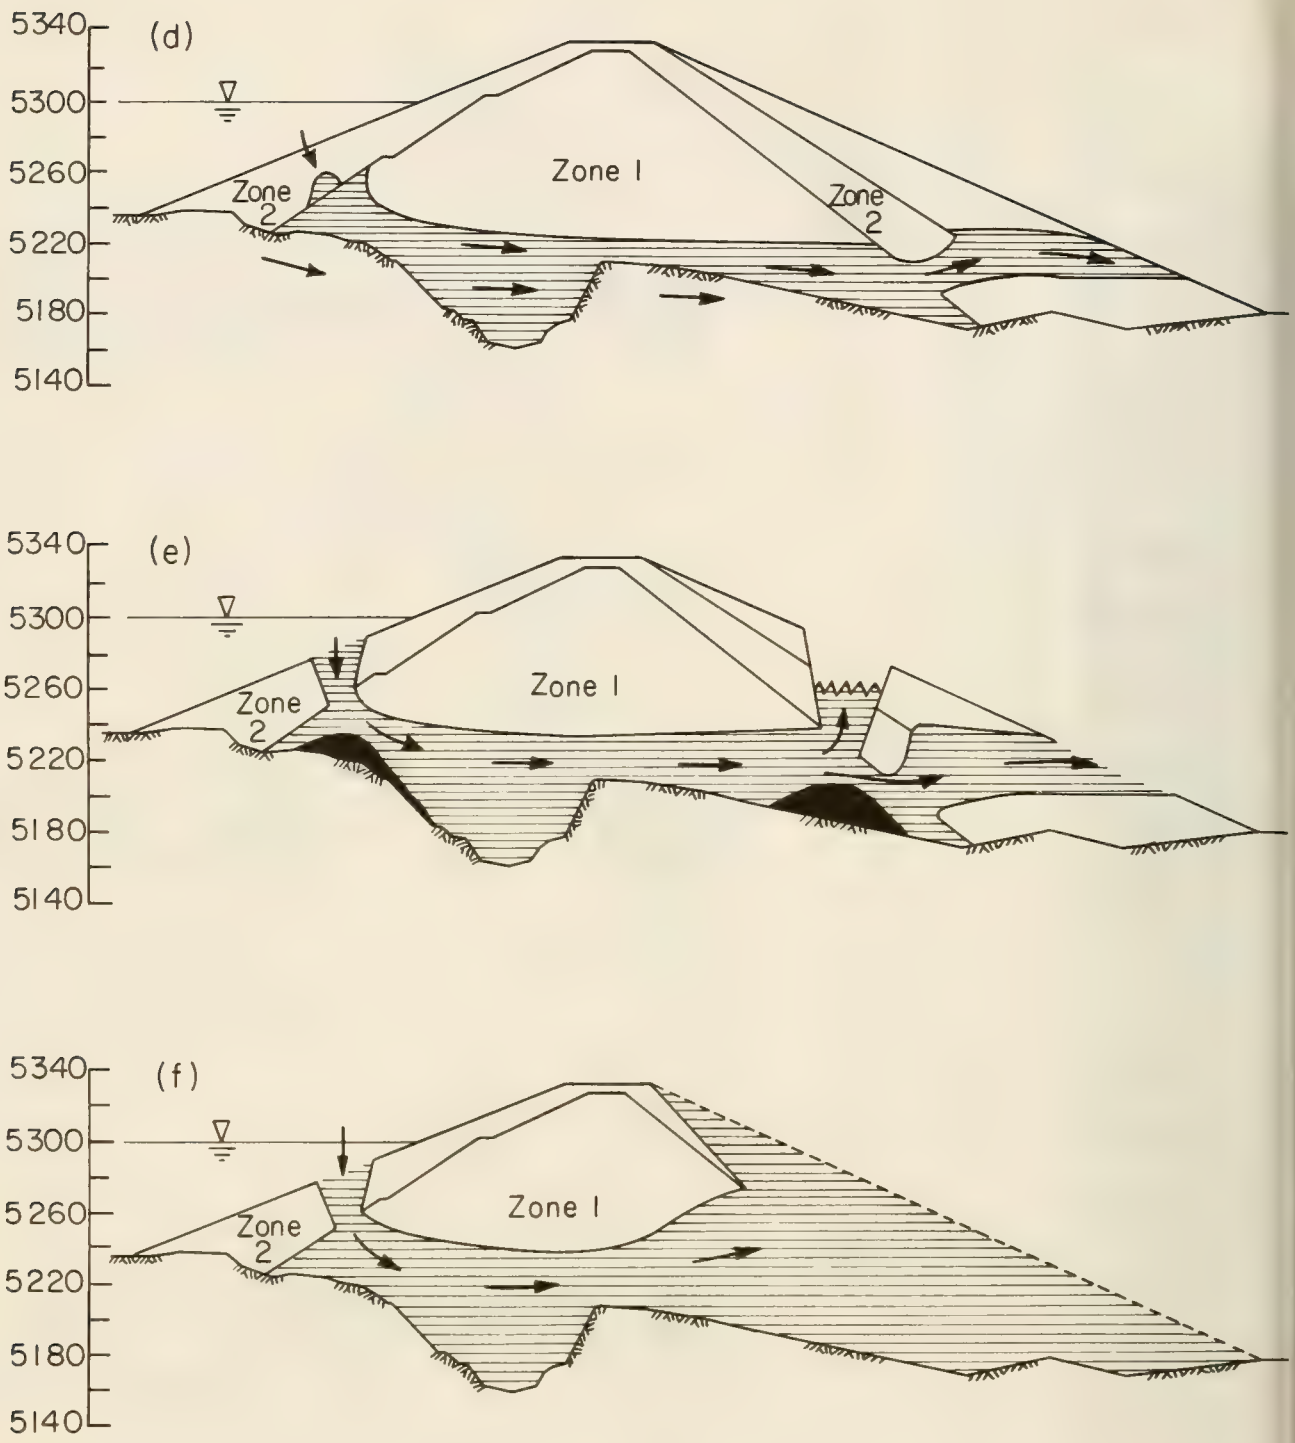
Figure 41.—Conceptual mechanism of progressive failure along section A-B-C (sheet 1 of 2).

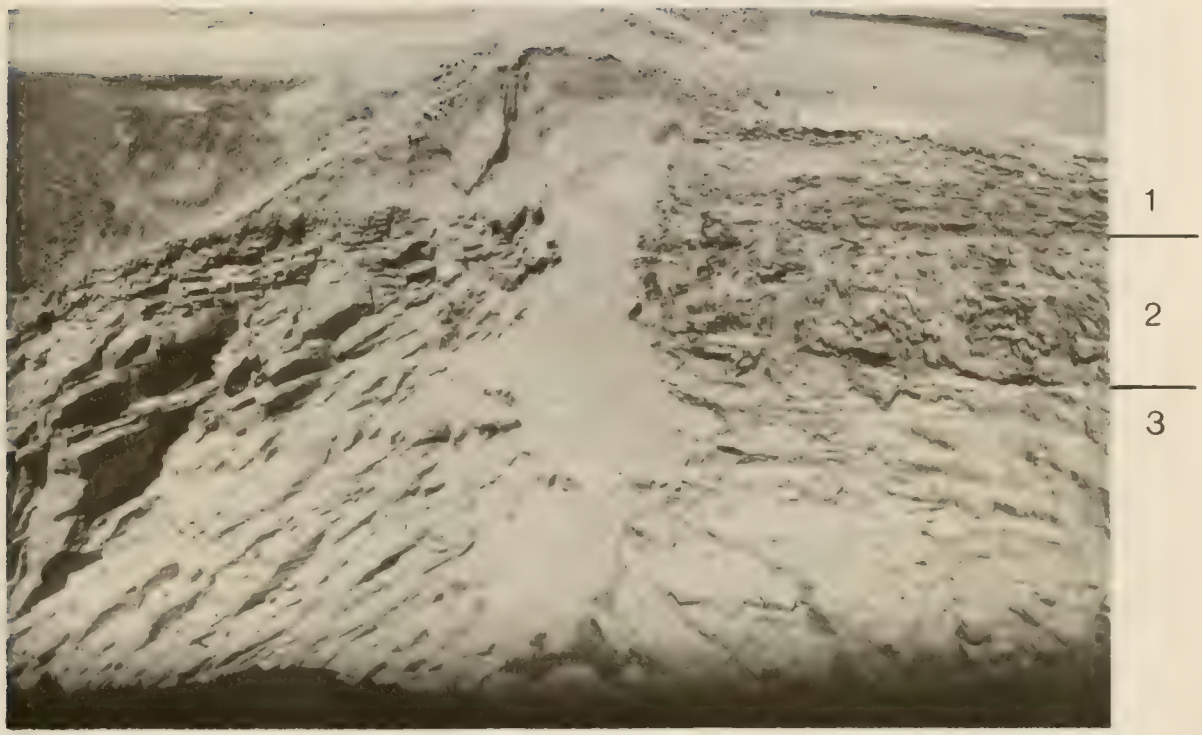
Figure B1-2.—Aerial view of right abutment, Teton Dam, nearly perpendicular to the canyon wall. Note abrupt termination of unit 2 just downstream from the embankment remnant. View to northwest taken June 1976.

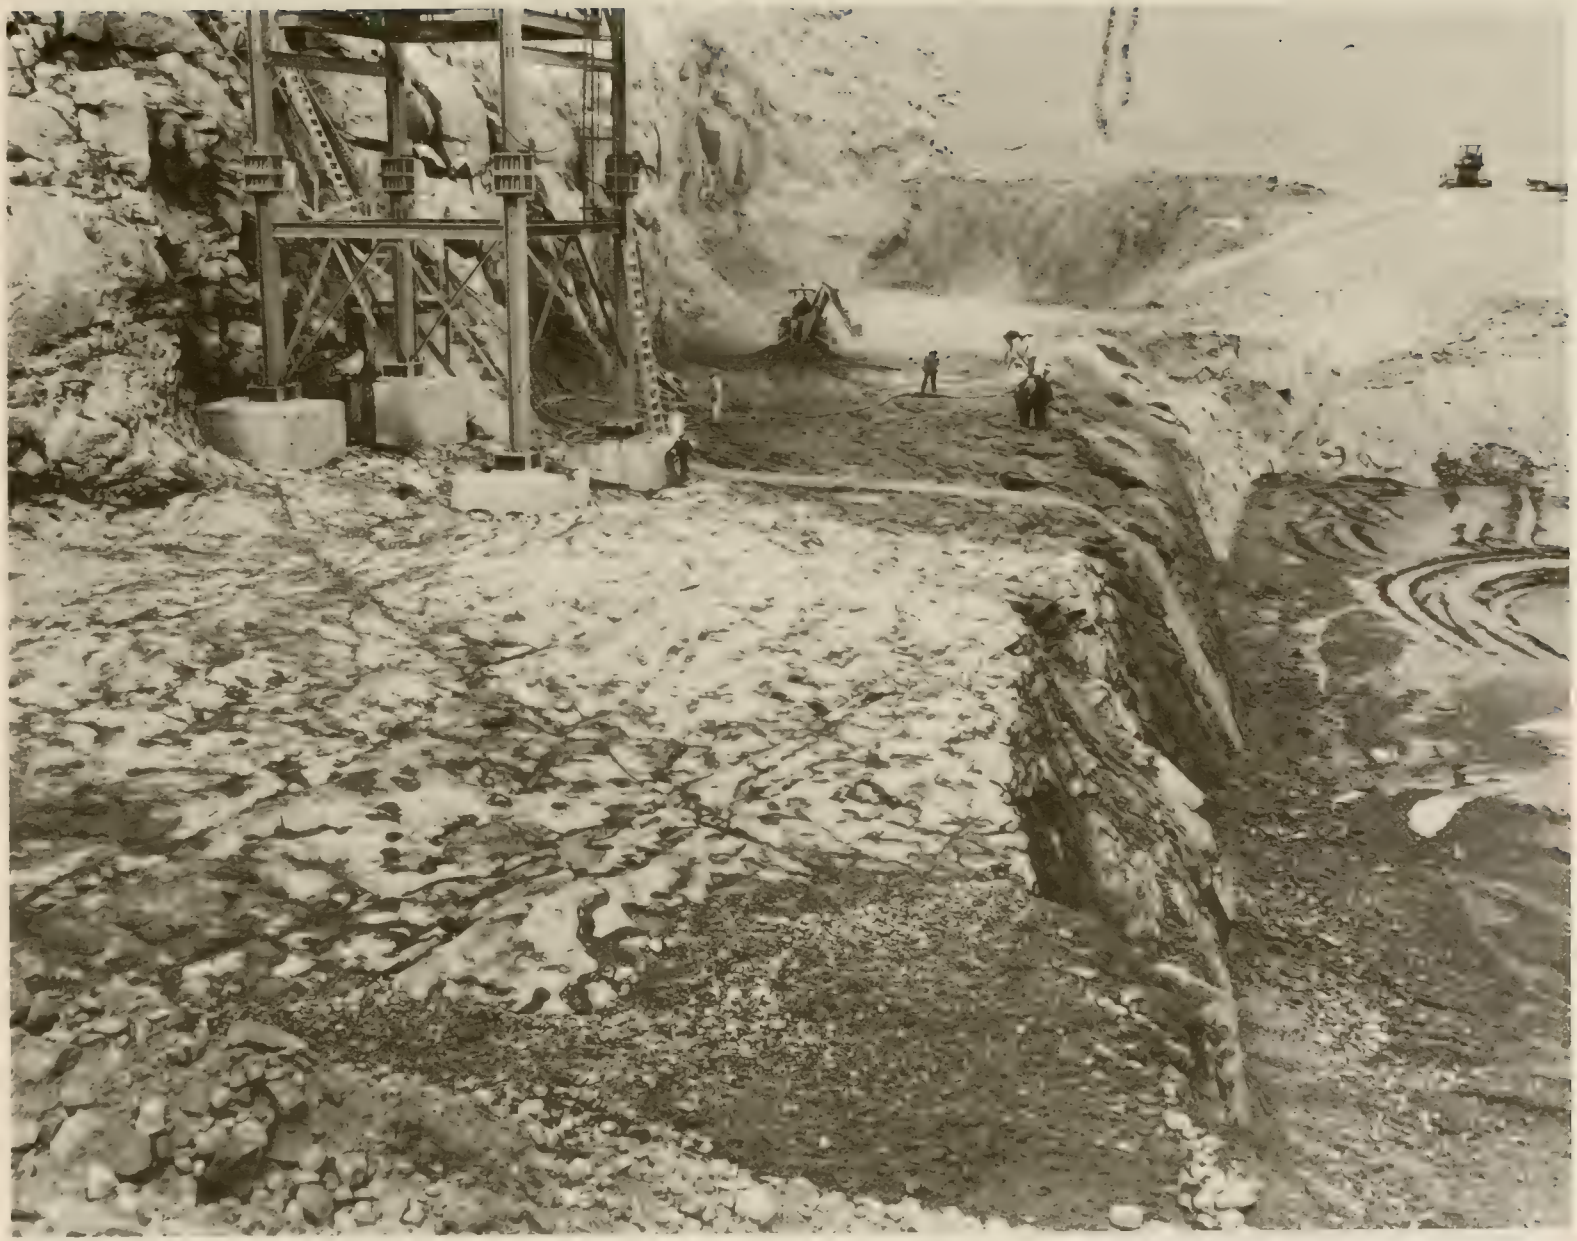
2.—View of grout cap looking toward right abutment in cutoff trench. Photo taken at station 19+00, 100 feet upstream from centerline of dam. 10/9/73; P549-147-3297 NA.

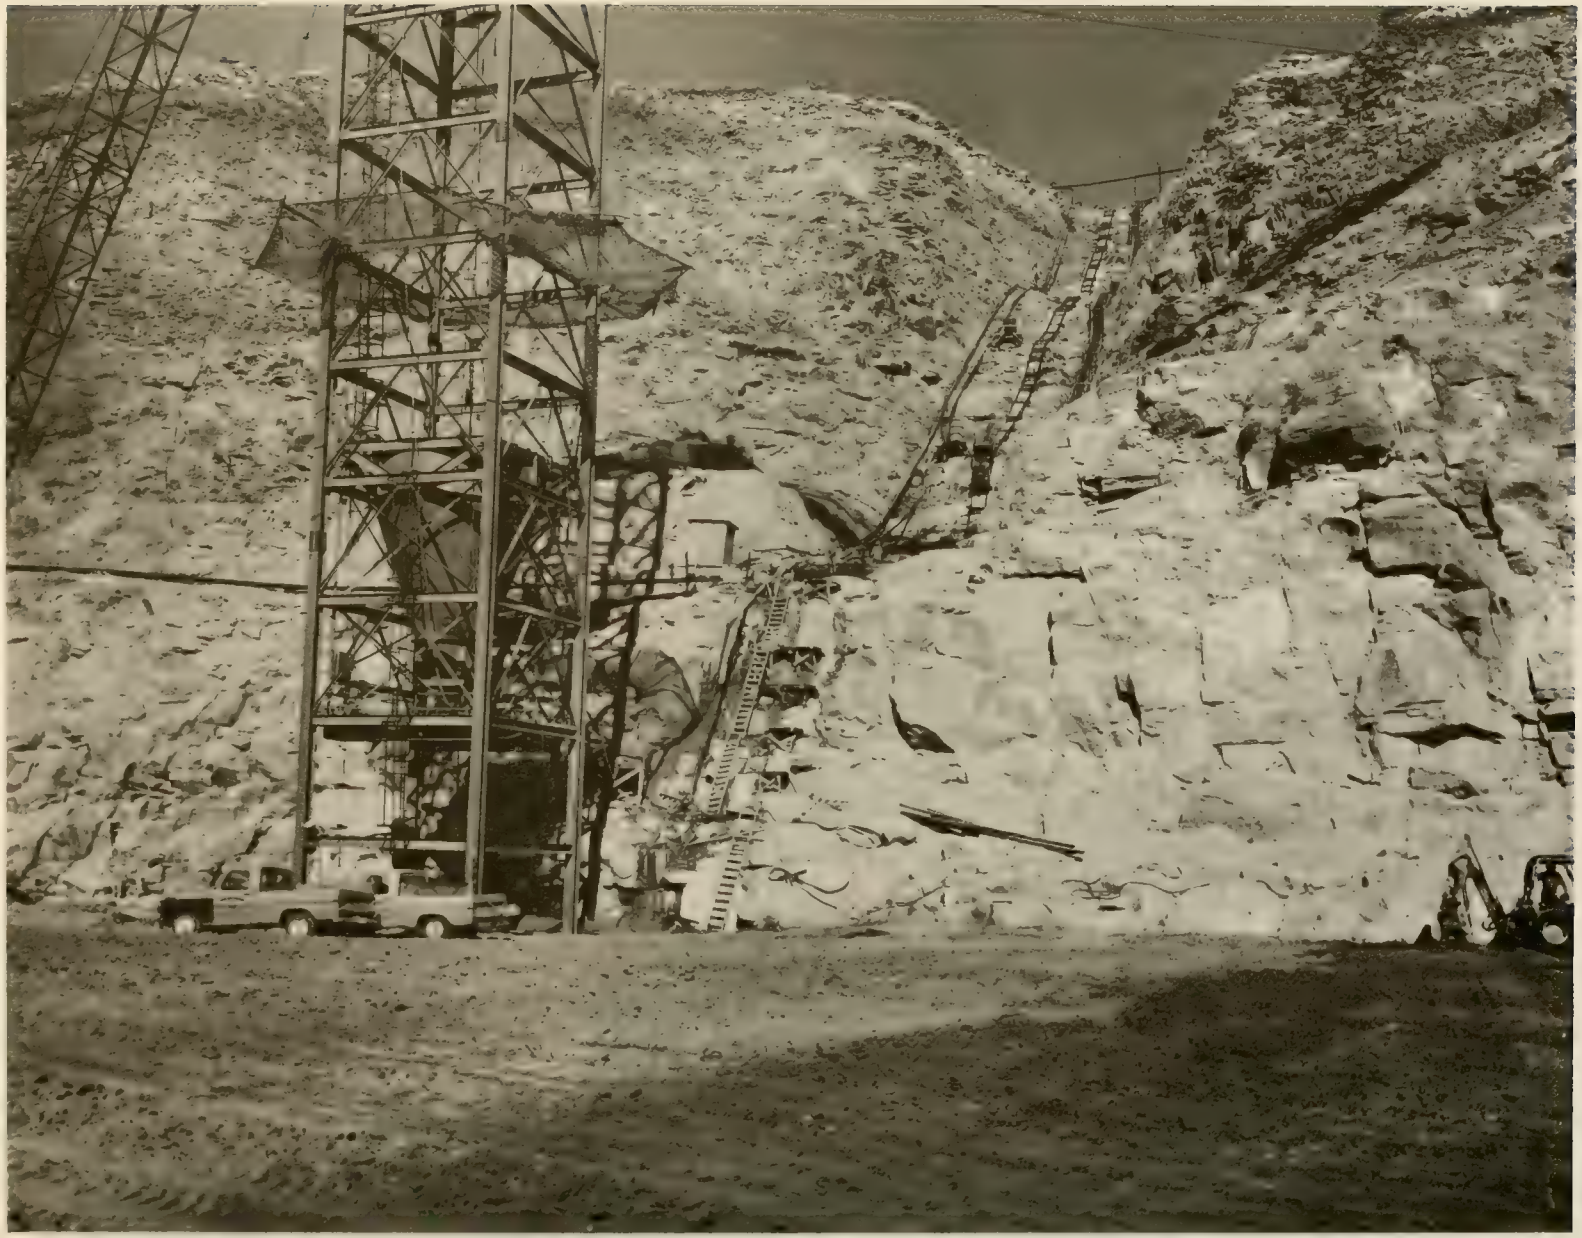
7.—View of cutoff trench. Photo taken at station 22+30, 180 feet upstream from centerline of dam, 4/12/74; P549-147-3994 NA.
